NASA TECHNICAL NOTE

NASA TN D-1861

**EXPERIMENTAL INVESTIGATION OF
INSULATING REFRACTORY-METAL
HEAT-SHIELD PANELS**

by Gregory R. Wichorek and Bland A. Stein
Langley Research Center
Langley Station, Hampton, Va.

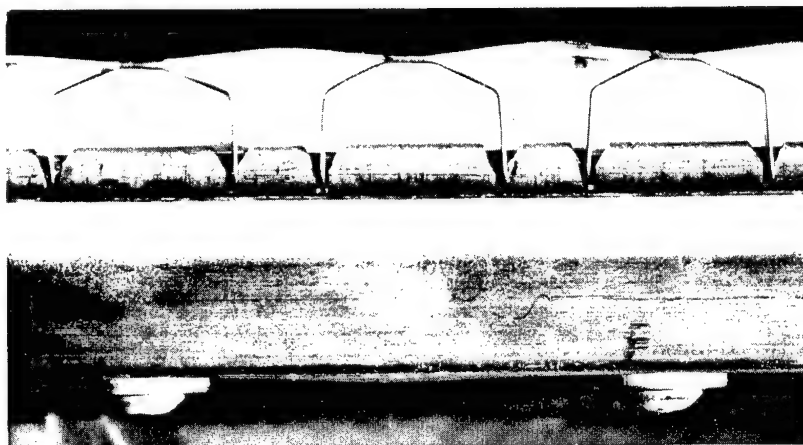
Figure 1.- Design details of heat-shield panels.

(a) Panel assembly.

(b) Rivet design for nickel-alloy and molybdenum-alloy shields.

(c) Riveted joints on molybdenum-alloy shields after application of silicide-base coating.

(d) Spot-welded joints on columbium-alloy shields.

^{No TP}
[Design]- Design details of the heat-shield panels are shown in figure 1. The shields, shield supports, and primary structure were fabricated from 0.010-inch- (0.025-cm-) thick sheet. The outer skin consisted of three overlapping sheets which were corrugated to a pitch of 0.75 inch (1.90 cm) and a depth of 0.060 inch (0.152 cm) as shown in figure 1(a). Shield supports were riveted to the molybdenum-alloy and nickel-alloy outer corrugated sheets and were spotwelded to the columbium-alloy outer corrugated sheets. The shields, the shield supports, and, where applicable, the rivets were made of the same material for each panel. The rivet design is shown in figure 1(b). This rivet was specifically designed to increase the gap between the supports and the outer corrugated sheet for better coating deposition as shown in figure 1(c). The spot-welded joints between the columbium-alloy supports and the outer corrugated sheet are shown in figure 1(d). The shield supports extended into slots machined in the channels which were spotwelded to the primary structure. (See figs. 1(a), 1(c), and 1(d).) Inconel rods, 0.093 inch (0.236 cm) in diameter and 19.8 inches (50.3 cm) long, were inserted into the channels and through the holes in the shield supports to attach the shields to the structure.

The primary structure consisted of a beaded sheet seam-welded to a corrugated sheet having 60°, 1/2-inch- (1.3-cm-) flat corrugations. (See fig. 1(a).) Z-stiffeners at each end of the corrugated sheet were seamwelded to the beaded sheet and blind riveted to the bottom flats of the corrugations. The primary structure was representative of the skin panel used in the investigation of a hot structure for lifting reentry vehicles (ref. 3).

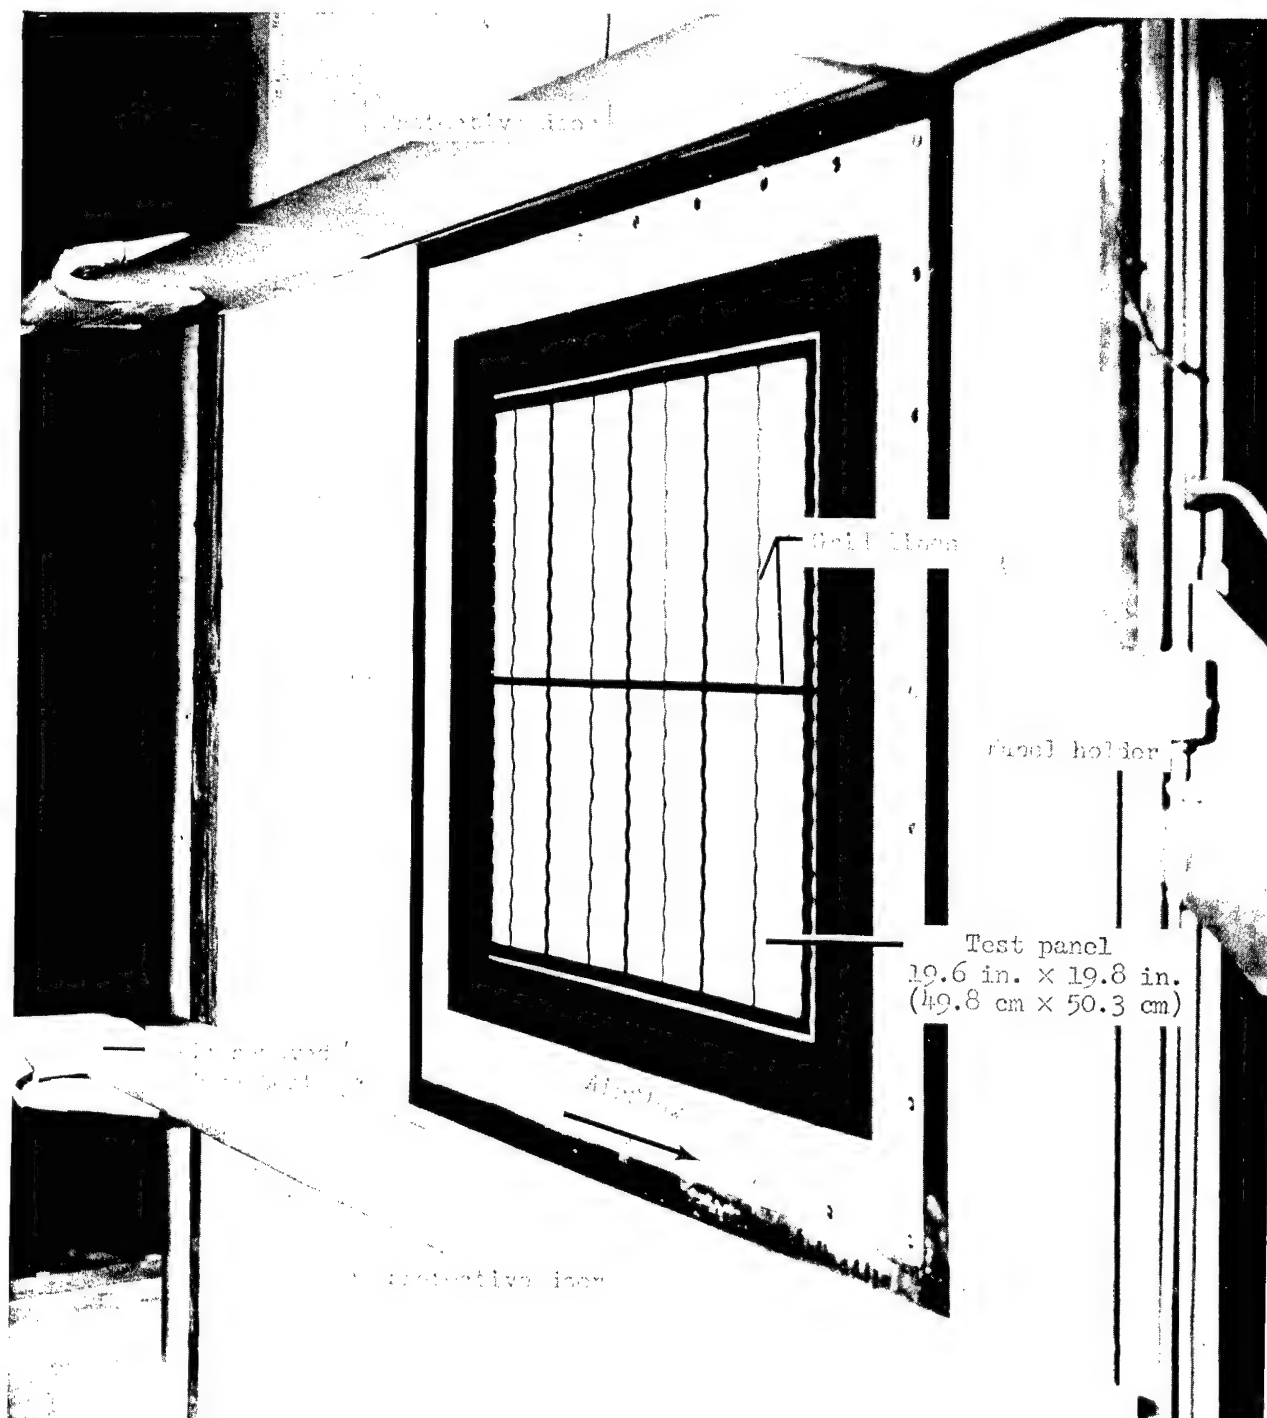
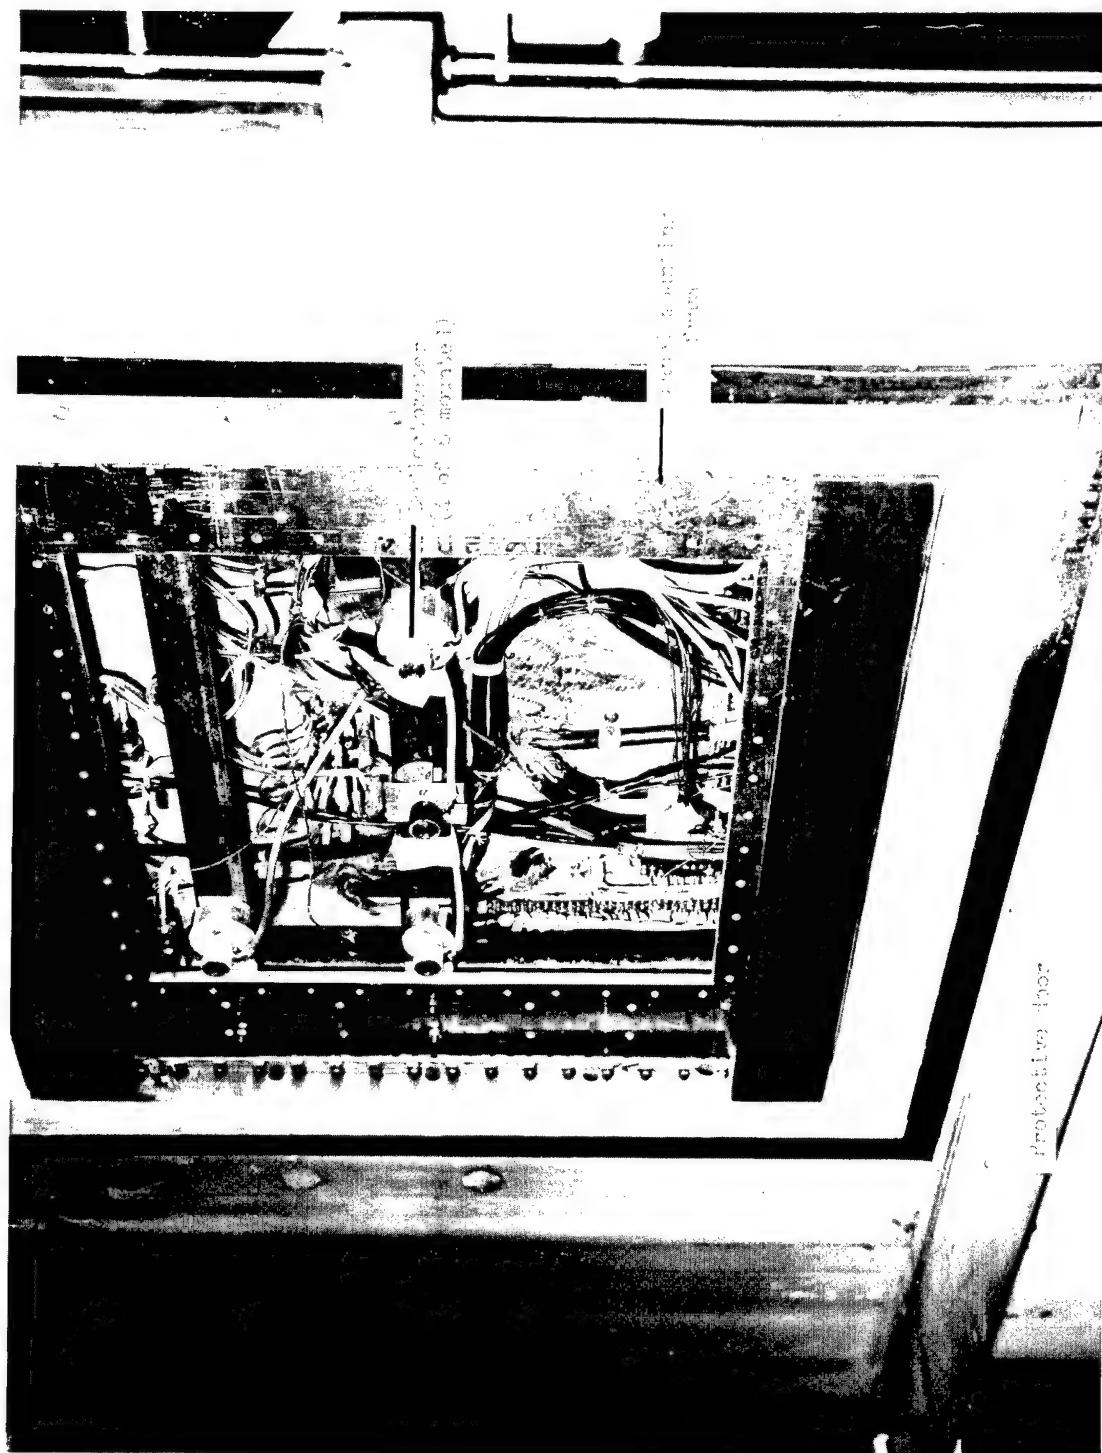
(a) Test panel mounted.

Figure 6.- Panel holder with protective doors in Langley 9- by 6-foot thermal structures tunnel.

(b) Test panel removed.

Wind-tunnel tests.- The nickel-alloy and columbium-alloy panels were tested under aerodynamic conditions in the Langley 9- by 6-foot thermal structures tunnel. The heat-shield panels were mounted in a panel holder at an angle of attack of 0° . (See fig. 6(a).) Airflow was at Mach number 3 with a stagnation temperature of 450°F (505°K), and the maximum temperature experienced by the panels was approximately 300°F (422°K). The nickel-alloy panel was subjected to stable free-stream dynamic pressures of $1,500\text{ lb/ft}^2$ (71.8 kN/m^2) and $2,500\text{ lb/ft}^2$ (120 kN/m^2) and the columbium-alloy panel was subjected to a stable free-stream dynamic pressure of $1,500\text{ lb/ft}^2$. The panels were aligned with the outer-skin corrugations first parallel and then perpendicular to the airstream at each dynamic pressure. The tunnel conditions were maintained for approximately 60 seconds. Sliding doors on the panel holder protected the panels from severe random pressure fluctuations which occur during tunnel starting and shutdown periods. (See fig. 6(a) and ref. 7.) After the doors were opened, the pressure differential across the specimen was maintained at less than $1/4\text{ psi}$ (1.72 kN/m^2) by means of an adjustable port on the panel holder.

Cameras and deflectometers were used to detect and record motion of the shields. Grid lines painted on the outer skin of the panels (fig. 6(a)) aided in the visual detection of motion. The cameras were operated at 750 and 250 frames per second. Six deflectometers were bolted to a heavy steel bar attached to the panel mounting frame to detect motion of the shields as shown in figure 6(b). The deflectometers were mounted $3/16\text{ inch}$ (0.476 cm) beneath the outer skin of the panel through $1\frac{1}{8}\text{-inch}$ (2.86-cm) holes in the primary structure and insulation. The inductance-type deflectometers are flat wire coils that are coupled by their electrical field with the resistance of the outer skin material to produce an electrical signal. The output signal limited the measurement of shield motions to inward deflections of $1/8\text{ inch}$ (0.318 cm) and to outward deflections of $1/16\text{ inch}$ (0.159 cm).
